PHOTOGRAPHIC INTELLIGENCE REPORT

VITAL RECORDS COPY
INDUSTRIAL ACTIVITY

NORTH VIETNAM

CIA/PIR75103

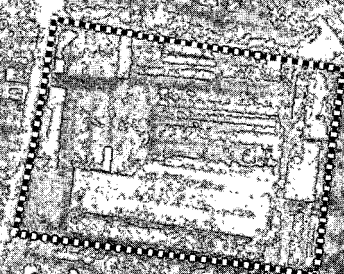
TRAN HUNG DAO ENGINEERING PLANT
HANOI, NORTH VIETNAM
21 00 36N - 105 51 16E

A review of photography of [REDACTED] showed numerous packing crates along the side of the largest fabrication building in the plant. Photography of [REDACTED] (Figure 10) revealed that nearly all of these crates had been removed. No other changes in status within the installation were noted.
